1.5.1 Asset Register Bus Shelter Condition Report Example

Bridgend Town Council
Bus Shelter Survey

Date	25.03.2021
Officer	K Davies

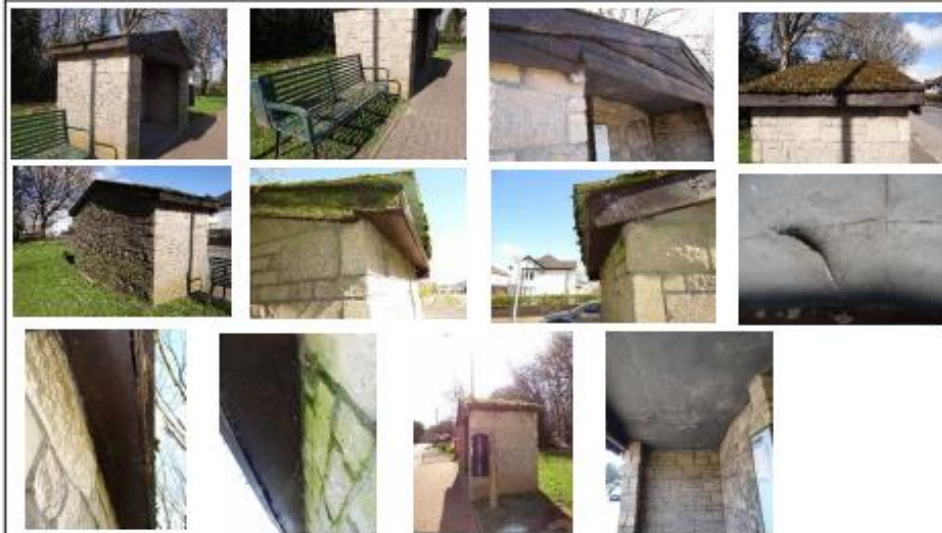
Stone built with "ceiling". Appears sound. Warped & split wooden panel to front fascia. Some rot to rear wooden panel corner. Ceiling inside pulled away slightly. Green bench to left side of structure. Located on privately owned BCBC land (not highway) - licence to occupy 4/10/17
