Site inspection 7 Feb 2023

Red Telephone Boxes

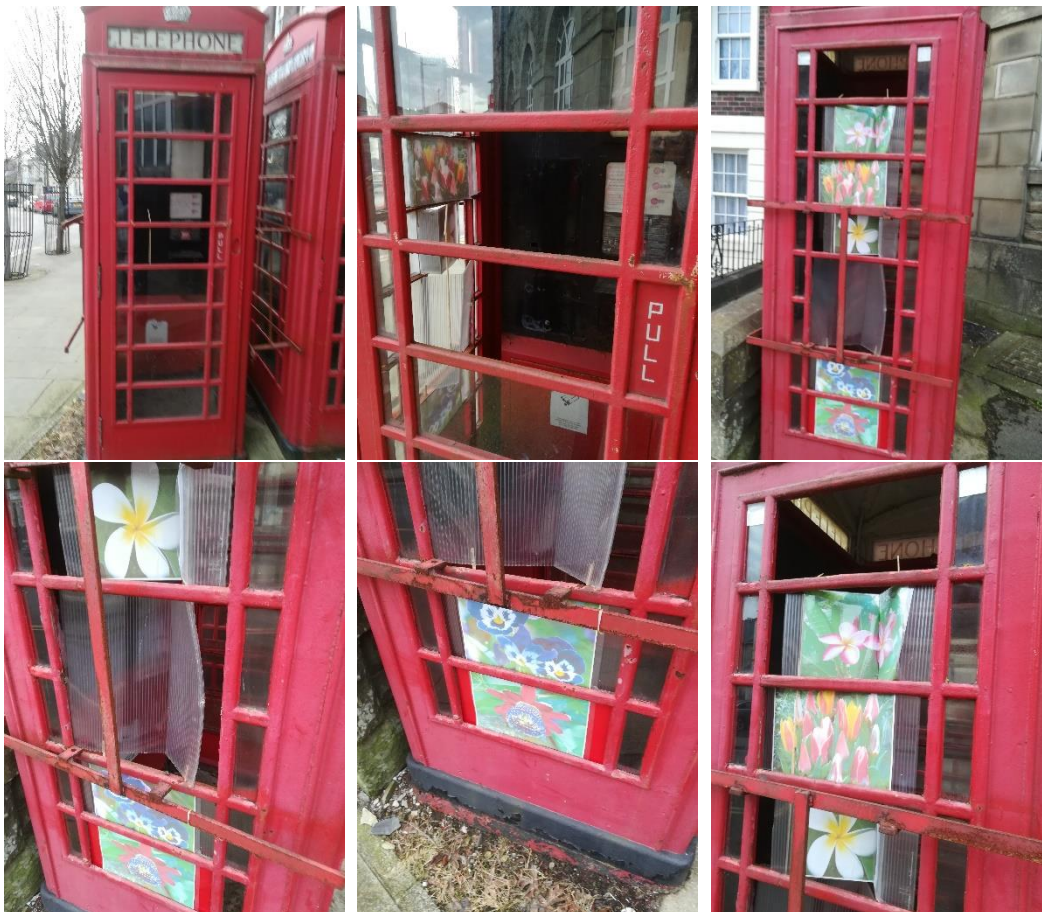
There are some small pieces of glass in the corner of the inside of the boxes but no pieces of broken glass left in the frames that could injure someone. Overall the paintwork is patchy with rust evident in many places. In order to overhaul the paintwork the sides facing each other (i.e the left hand side of box 1 and the right hand side of box 2) would be difficult to repaint due to the narrow gap between the boxes.

The "Banding" around the box appears to be an older framework and has been sawn through and removed on the front side. There appears to be no evidence of any other more recent banding around the boxes.
